**Review of IWM study of river
bank erosion management in
Polder 29, Khulna,
Bangladesh**

Erik Mosselman

Summary

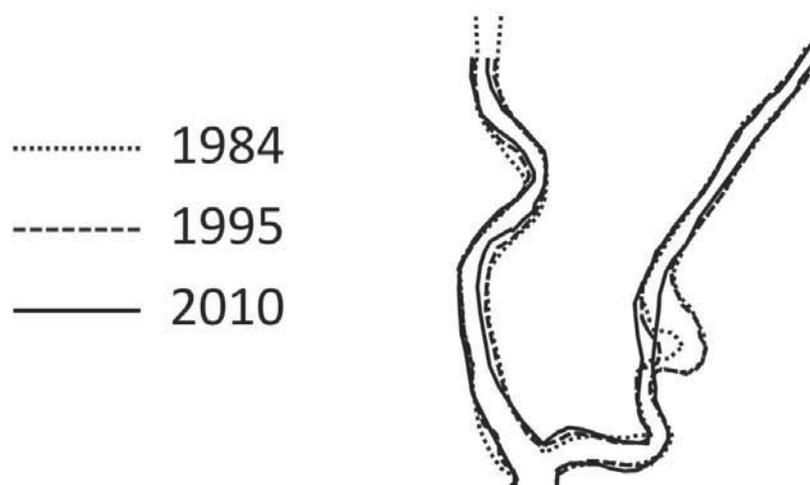
Figure 2.1. General river planform development around southern part of Polder 29 in period 1984-2010 (source: Landsat images at <http://world.time.com/timelapse/>).

The current management of river bank erosion along Polder 29 is based on the principles of “adaptive delta management” and “living with water”. Wherever bank erosion threatens the embankments, the embankments are retired to a new location. The evolution of river planforms in the 25 years between 1984 and 2010, presented in Figure 2.1 of the present document, demonstrates that the river banks are mostly relatively stable. The planimetric changes due to bank erosion are small compared to the planimetric changes of the major rivers Brahmaputra-Jamuna, Ganges and Padma. The current adaptive approach thus seems feasible. The objective of the study, however, is to develop an approach for erosion protective work, irrespective of the costs involved. This leads to proposing bank protection over a length of in total 3 km. The capital investment for this protection can be estimated roughly to be in the order of a million euro, entailing subsequent maintenance costs in the order of 100,000 euro per year. The report does not present any economic underpinning for this solution. The costs have been compared neither with the annual damage due to erosion nor with the costs of retiring the embankments. Such a comparison is recommended for a good evaluation of different alternative solutions.

IWM (2015) analyzed river planform evolution on satellite images from 2000 to 2015. In order to extend the period of observation, Figure 2.1 of the present document presents the river planform evolution on satellite images from 1984 to 2010. The river banks are mostly found to be relatively stable, with the exception of the bank at Chandgar. Here prominent bank erosion occurs in relation to the straightening of a river bend. Figure 2.2 of the present document shows this development along with an interpretation of the associated main bank erosion. Extrapolation of this development suggests that substantial bank erosion may proceed to Jaliakhali and even the bank East of Baroaria. Figure 5.8 shows, however, that no protection is planned along that vulnerable bank.

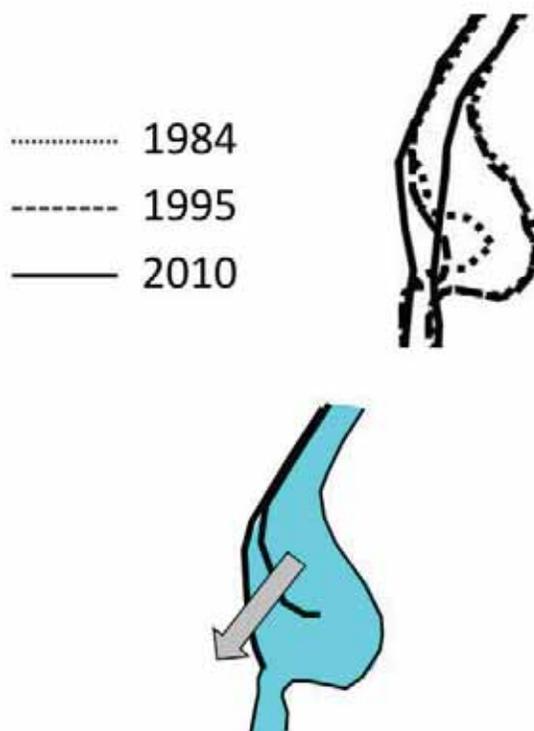
Figure 2.2. Local river planform development (top) and corresponding interpretation of main bank erosion (bottom) at Chandgar in period 1984-2010 (source: Landsat images at <http://world.time.com/timelapse/>).

Figure 5.8 shows that no protection is planned along the bank at Jaliakhali. Extrapolation of the interpretation of bankline development in Figure 2.2 of the present document suggests, however, that substantial erosion may be expected there in the near future. This erosion might proceed even further up to the bank East of Baroaria.

Flat slopes and accreting environments offer possibilities for Building-with-Nature-type of solutions. Figure 2.2 of the present document suggests that the wide river area at Chandgar might be suitable for this. It might be possible to dredge the dying bend of this area and to dump the dredged material in the channel along the actively eroding bank. A feasibility study for this solution is recommended.

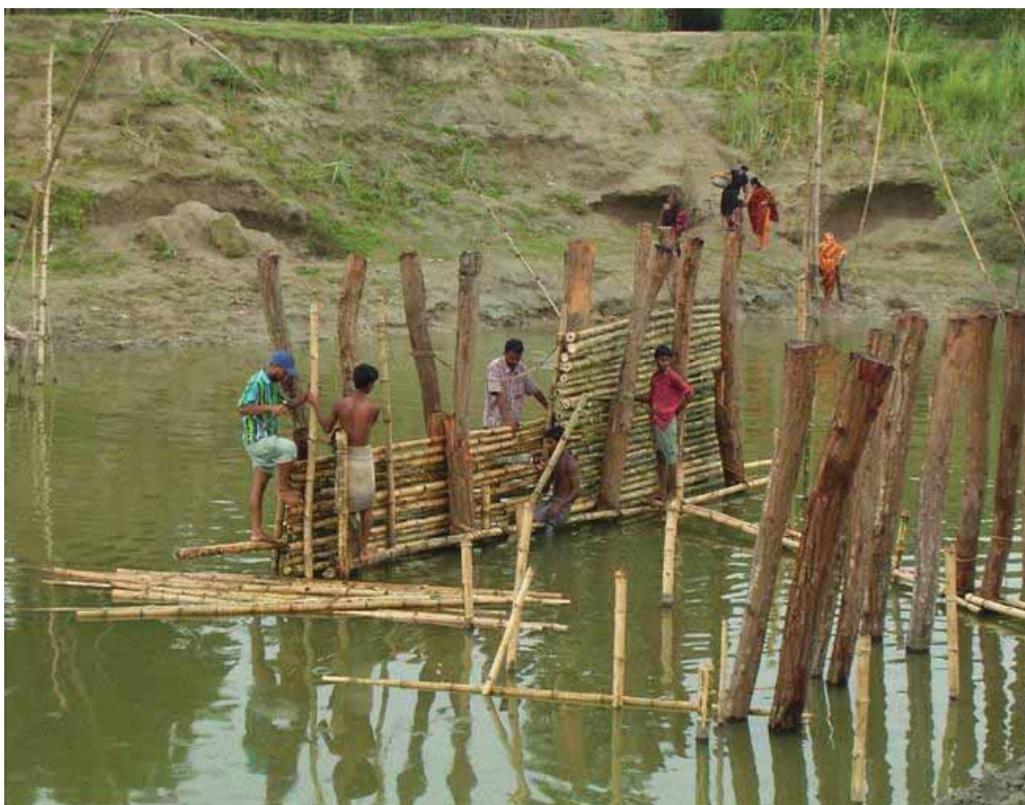
Figure 2.3. Bottom vanes under construction in the Elanjani river (Tangail).

The report explains the functioning of bottom vanes from helical flow, diversion of slower-moving bottom water towards the bank, sediment pick-up from the suction side of vanes and sediment deposition at the pressure side. In reality, the diversion of slower-moving water hardly plays a role. The other mechanisms do play a role, but do not represent the full picture. A field test of bottom vanes in the Elanjani river (Tangail) by BUET and Delft University of Technology (Hossain & Mosselman, 2006) has shown that overall flow deflection and increased turbulence are important mechanisms too. Figure 2.3 of the present document shows the bottom vanes of the field test under construction. This successful application in Bangladesh is worth mentioning in addition to the failed application in the Meghna Estuary on page 44. Nonetheless, the experiences from the Elanjani river confirm the IWM (2015) assessment that bottom vanes are not suitable for the rivers around Polder 29. Their applicability is limited to relatively small rivers or river channels with a well-defined geometry that experiences only slow changes in time.

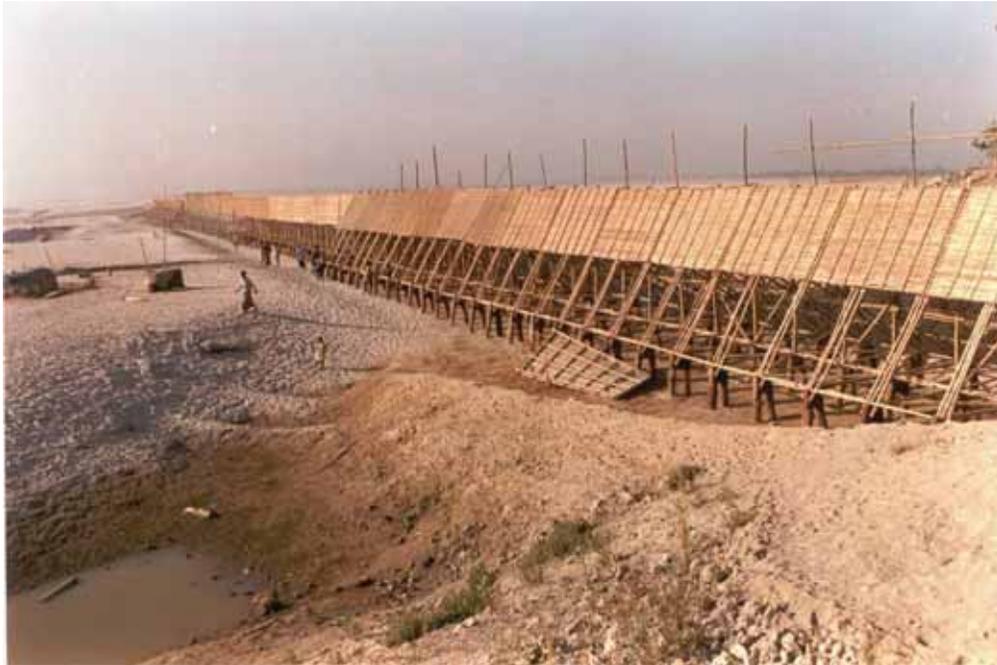
Figure 2.4. High-water bandal test structure in the Brahmaputra-Jamuna river at Katlamari.

For bandalling, page 45 refers to recent experiences on the Ganges in India. However, well-documented experiences are available from pilot tests on the Brahmaputra-Jamuna river in Bangladesh too (Jamuna Test Works Consultants, 2001a). Figure 2.4 of the present document shows the high-water bandalls that were tested in this framework at Katlamari. Similarly, page 46 refers to experiences with permeable groynes in Europe and North America, whereas one of the most extensive and well-documented field tests has been carried out on the Brahmaputra-Jamuna river in Bangladesh (Jamuna Test Works Consultants, 2001a). Figures 2.5 and 2.6 of the present document show the corresponding permeable groyne test structures at Kamarjani. It is recommended to review and use the lessons learnt in these Bangladeshi field tests when selecting and designing bank protection along the rivers at Polder 29.

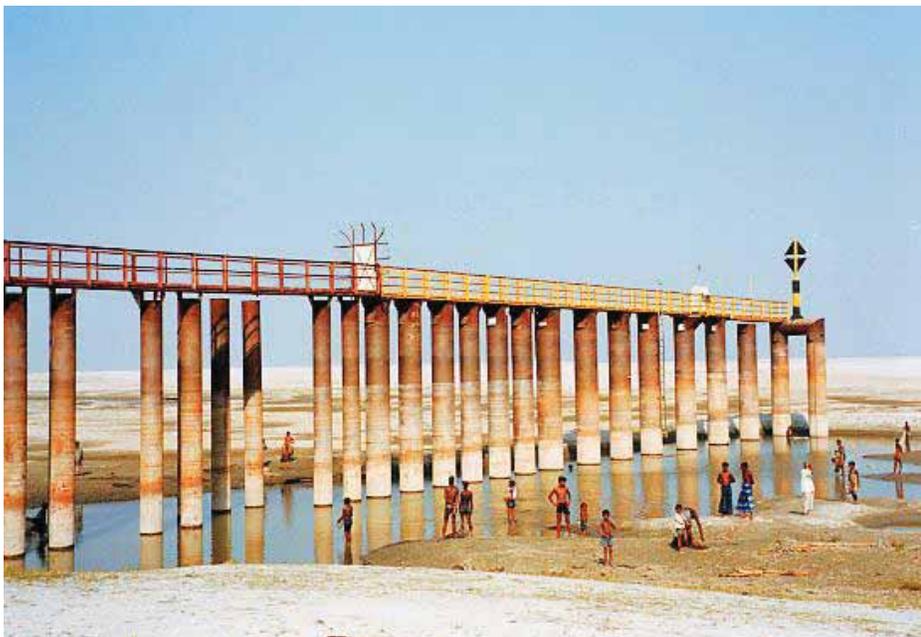
Figure 2.5. Permeable groyne test structure in the Brahmaputra-Jamuna river at Kamarjani in the dry season.

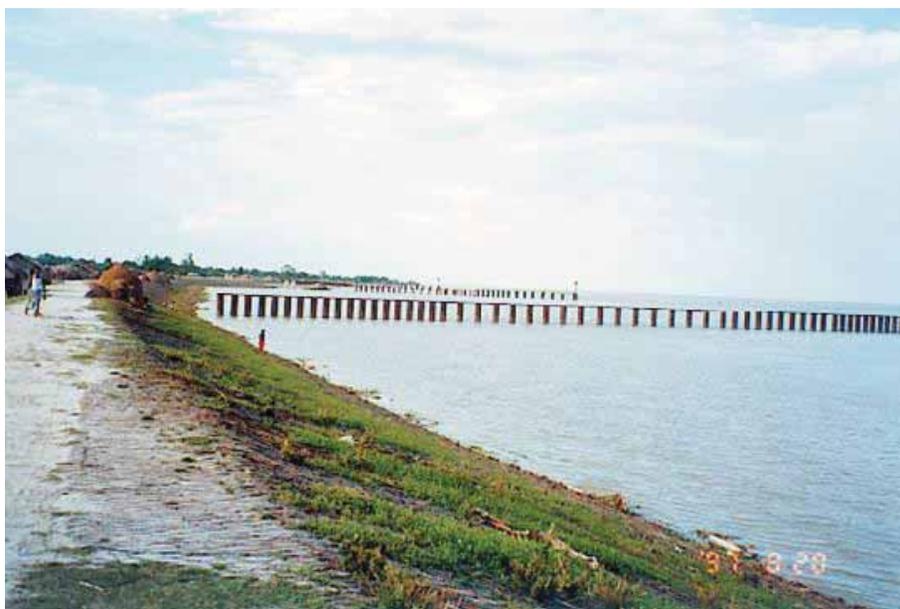
Figure 2.6. Permeable groyne test structure in the Brahmaputra-Jamuna river at Kamarjani in the wet season.
